AIR RESCUE REPORT

International Commission for Alpine Rescue (ICAR)
Kommission für Luftrettung/Commission pour le Sauvetage Aérien

October 18-21, 2017
Soldeu, Andorra

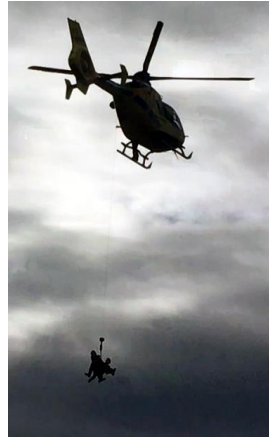
During the Friday evening social hour, the host team demonstrated a rescue of a subject from a cable.

One of the demonstrations was of a rescuer being inserted by helicopter hoist to a subject suspended from a chairlift cable.

Once free of the helicopter hoist system, the rescuer then rigged a separate system to lower the subject to the ground.

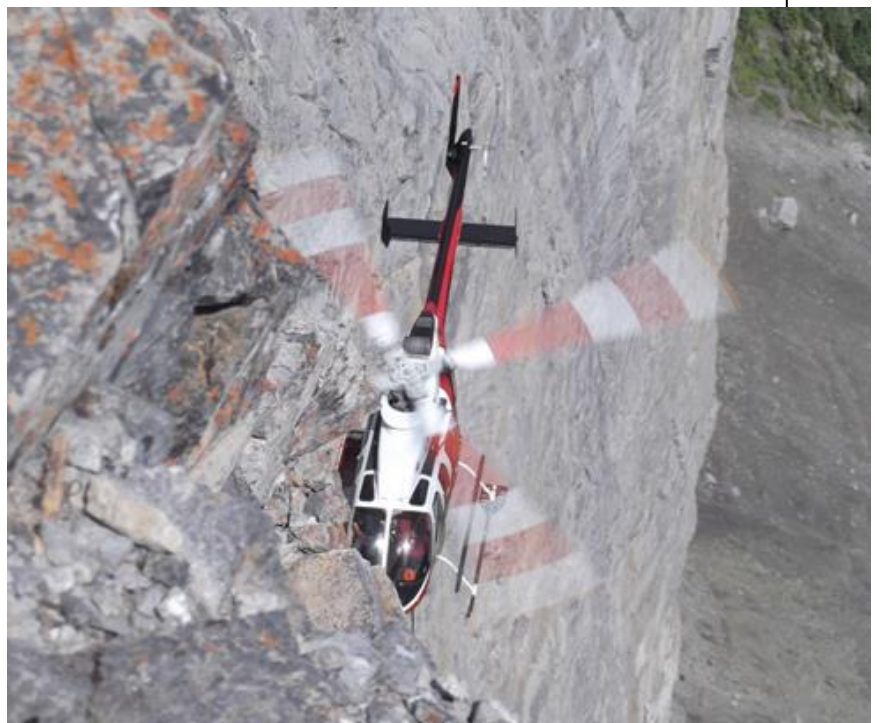
Moments after this photograph was taken, this helicopter's main rotor blades struck the rock at the 3 o'clock position during an attempt to insert a rescuer on a longline. There were no injuries, but the aircraft suffered significant damage

While performing a fixed line Class D mission on a steep rock face, the helicopter blades struck the cliff face. The pilot was able to maintain control of the aircraft, drop the rescuer off and then land without further incident. There were no injuries, but the aircraft suffered significant damage. The pilot described reacting to a wind gust prior to the blade strike.

The conclusion was that there was not enough rotor clearance for safe operations. A suggestion was made that in steep terrain sling operations, a “dry run” is conducted (with no rescuer on line) in order for the pilot to get a better sense of operational limits.

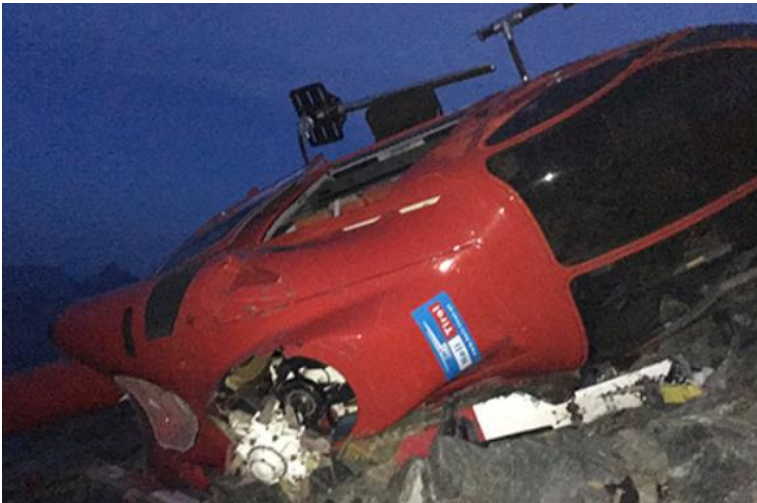
An Austrian rescue helicopter (MD902) with three persons on board landed at an alpine shelter at 11,300 feet (+7 degrees C) to pick up one patient with a suspected heart attack. When the helicopter attempted to take off after loading the patient, tail rotor effectiveness was lost, the aircraft began to turn in a clockwise direction and then tipped to the side and crashed. There was one injury.

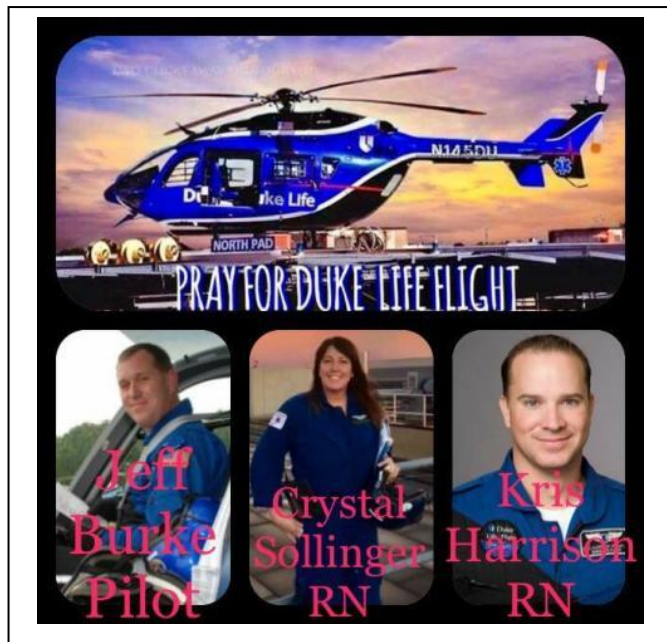
Another Possible Engine Failure

Duke University, "Life Flight" – Perquimans County, North Carolina (September 8, 2017) – The MBB BK117-C2 helicopter, N146DU, was en route to Duke University Hospital from Sentara Albemarle Medical Center. Several witnesses reported observing "heavy/dark" smoke trailing behind the helicopter, also a "popping noise," They then watched it turn twice and descend before it disappeared from sight. The pilot, two flight nurses, and the patient died in the crash.

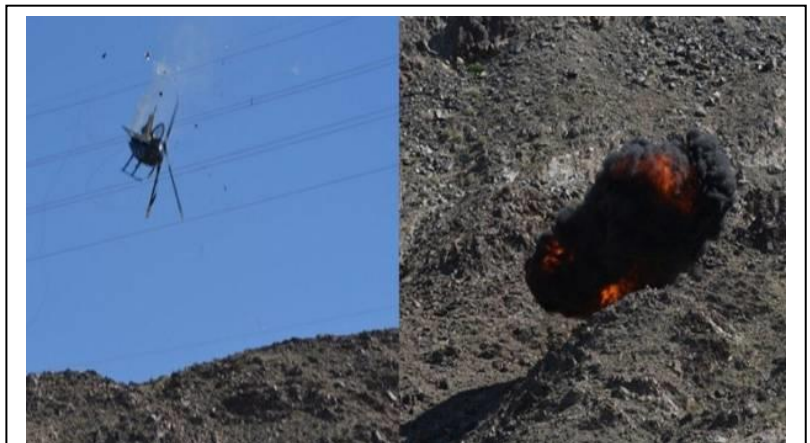
Four rescuers were killed in the crash of this helicopter when it encountered power lines during a body recovery of a deceased hiker.

The government says the crew had found the woman's body and was bringing back rescue workers when the helicopter hit an electrical power cable. All four on board died.

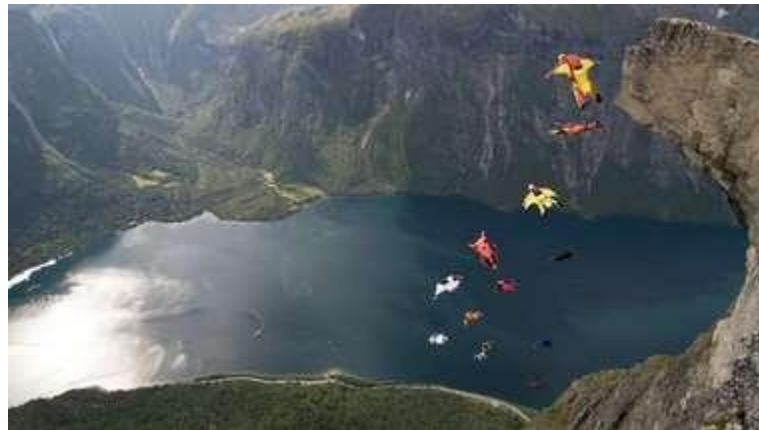
- Difficult and dangerous access to victim
- Is the victim alive or deceased (difficult decision from the helicopter window).

The risk of getting too close with the helicopter and re-inflating the parachute and blowing patient or body away was discussed. (The presentation profiled one case where a body (deceased) was blown away by downwash from the helicopter.)

This presentation examines and compares the effect of downwash on a deployed base jumper's parachute (attached to a simulated person) by a Sea King helicopter (8500 kg) and an EC 135 helicopter (2600 Kg). Not surprisingly the Sea King's downwash inflated the chute and caused movement sooner than the EC 135 but what was surprising is that both helicopters inflated the chute and caused movement from as far away as 400 feet. Also of note is the chute remained inflated for a period of time after the helicopter had left. The take home from this study is that you cannot get close to a base-jumper accident site (where the chute is deployed) with a helicopter without risking moving the subject.

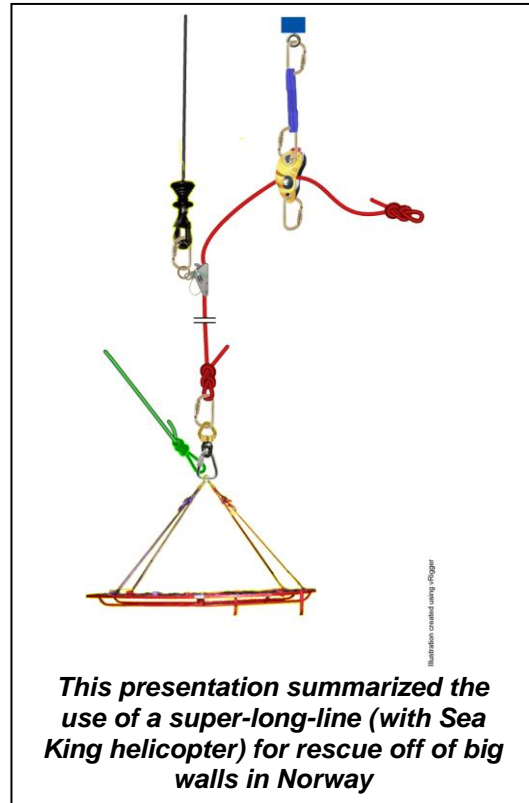
This presentation summarized the use of a super-long-line (with Sea King helicopter) for rescue off of big walls in Norway. This technique is a rope extension to the hoist cable and allows the helicopter to stay above the rim of the wall.

Once the rescuer and patient are suspended on the super-long-line then the load and rope can be hoisted into the helicopter.

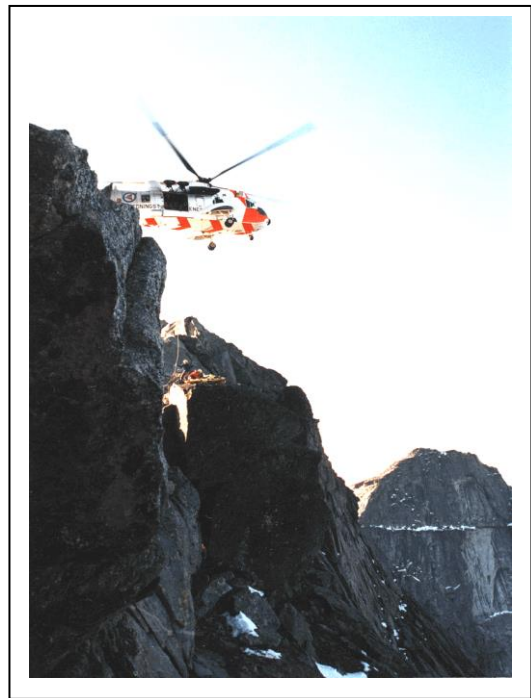
Texbor Smart Sling For Class D

Smart-Sling presentation
